Luddenham Quarry Modification Report DA 315-7-2003 MOD5

Aboriginal Heritage Due Diligence Assessment

Luddenham Quarry - Modification 5

Aboriginal heritage due diligence assessment

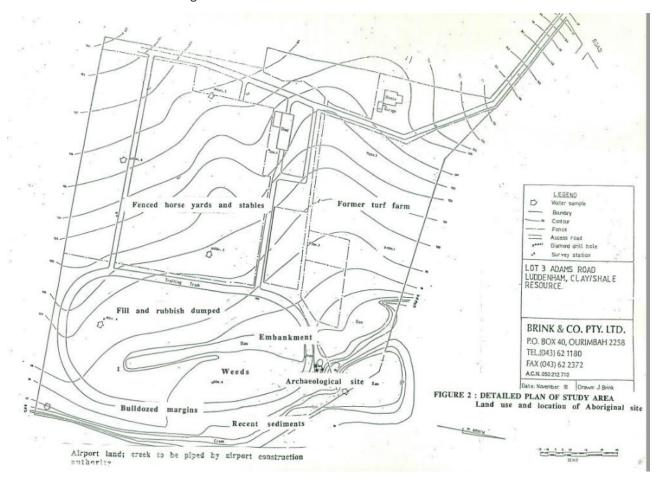
Plate 2.1 Map of the study area showing land use in 1991. Note that the map is rotated, and north is to the right. (Source: EIS Appendix 7, Pam Dean-Jones 1991)

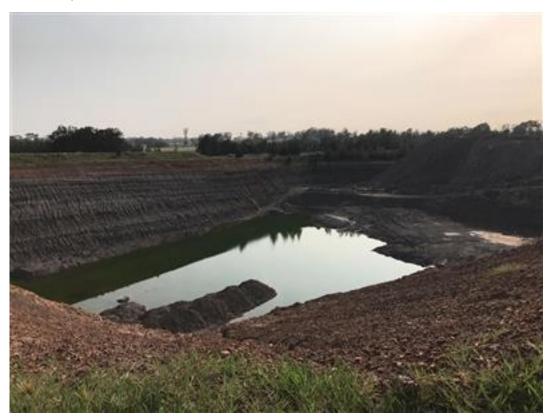
More recent disturbance has been most intensive in the southern half of the study area with the establishment of a clay/shale quarry which was approved in 2003 (Figure 1.2). The quarry extraction footprint is bordered by a stockpiling area and earth noise bund to the west, an earth bund to the north and internal access roads to the south and east.

Plate 2.2 Existing quarry, view north east

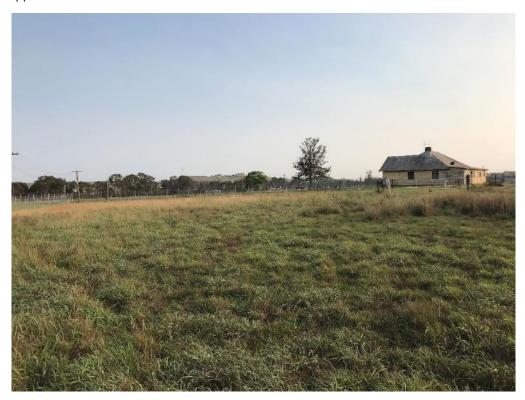
Plate 4.1 Location of proposed weighbridge and office in north-east corner of the site. Dense pasture grasses and low surface visibility. View north.

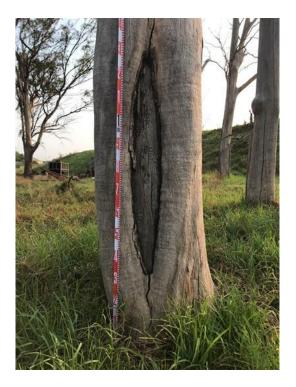
Plate 4.2 Tree with scar to the west of stockpile area. Existing stockpile/bund in background. View north east.

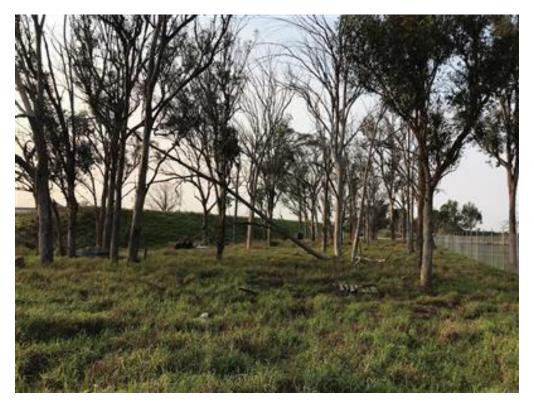
Plate 4.3 Woodland area of young trees affected by dieback, western study area. Tree with scar is in the background. View south.

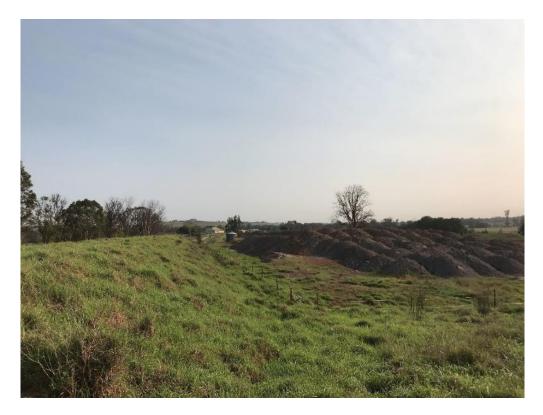
Plate 4.4 Bund and stockpiles. Photograph taken from south west corner of the site. View north.

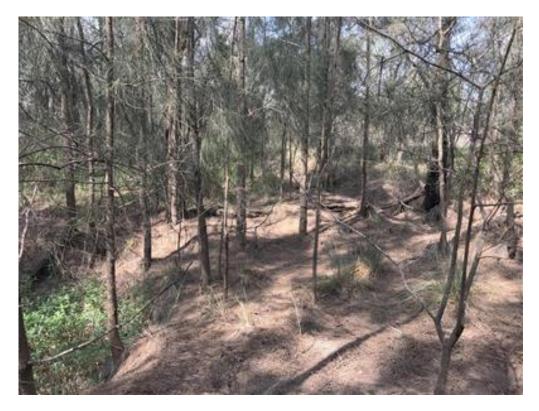
However, the eastern corridor of the study area, encompassing the riparian zone on the west side of Oaky Creek, has been less disturbed (Plate 4.5). Site inspection confirmed the assessment of previous reports (Navin Officer 2016) that this area has higher potential for Aboriginal cultural material to be present. However, it should be noted that a series of dams and earthworks, in the north-east corner of the study area, has impacted the flow of Oaky Creek and disturbed the ground surface. At the time of the site inspection, Oaky Creek was dry. Ground surface visibility was limited by a dense coverage of casuarina needles. An access track that runs north to south between the quarry and Oaky Creek has been raised and levelled with introduced fill (Plate 4.6).

Plate 4.5 Elevated terrace flat beside Oaky Creek. Potential for Aboriginal objects in this woodland area on the west side of Oaky Creek. Negligible surface exposure. View south.

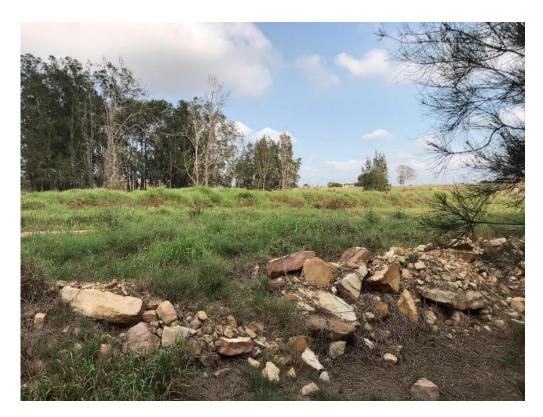
Plate 4.6 Fill used to create a level surface for the road. Bund beside dam behind. View north west.

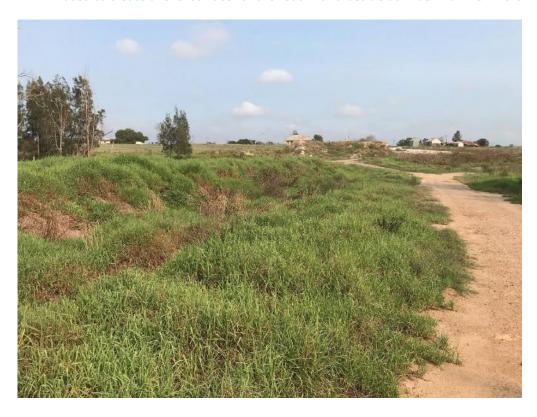
The one recorded AHIMS site in the study area (#45-5-2280) was inspected. However, the site inspection found that the spatial coordinates on the AHIMS database do not match its physical location in the study area (Plate 4.7). The recorded AHIMS location was inspected and found to have a high level of disturbance from creation of the road, the dam walls and a nearby noise bund. High grass limited the ground surface visibility. No artefacts were identified. Approximately 50 m to the east of the recorded AHIMS location is a fenced area that marks the true location of the AHIMS site. The corrected location of #45-5-2280 is shown on Figure 4.1. The securely fenced area is located beside

Plate 4.7 Incorrect location of AHIMS site #45-5-2280 as recorded on the AHIMS database. View north.

- 1. AHIMS site #45-5-2280 continues to be avoided and protected by fencing.
- 2. The corrected coordinates for AHIMS site #45-5-2280 are entered in the AHIMS database.

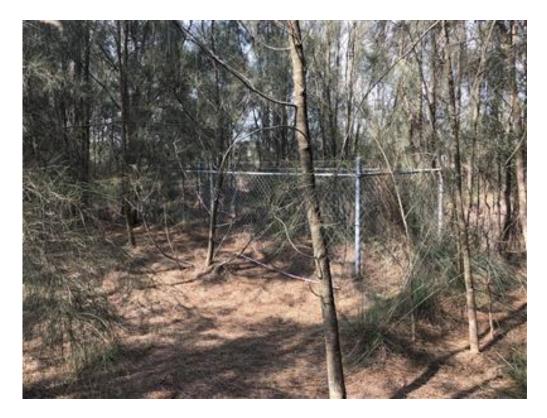
Plate 4.8 Fenced area around AHIMS site #45-5-2280. View north.

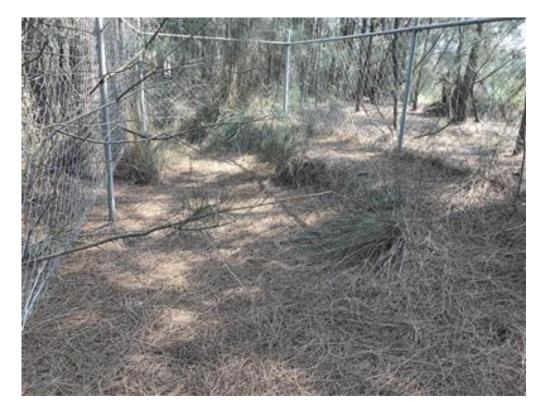
Plate 4.9 AHIMS site #45-5-2280. Eroded bank within the enclosure where artefacts were identified.

Area is now covered in a deep layer of Casuarina needles View north.

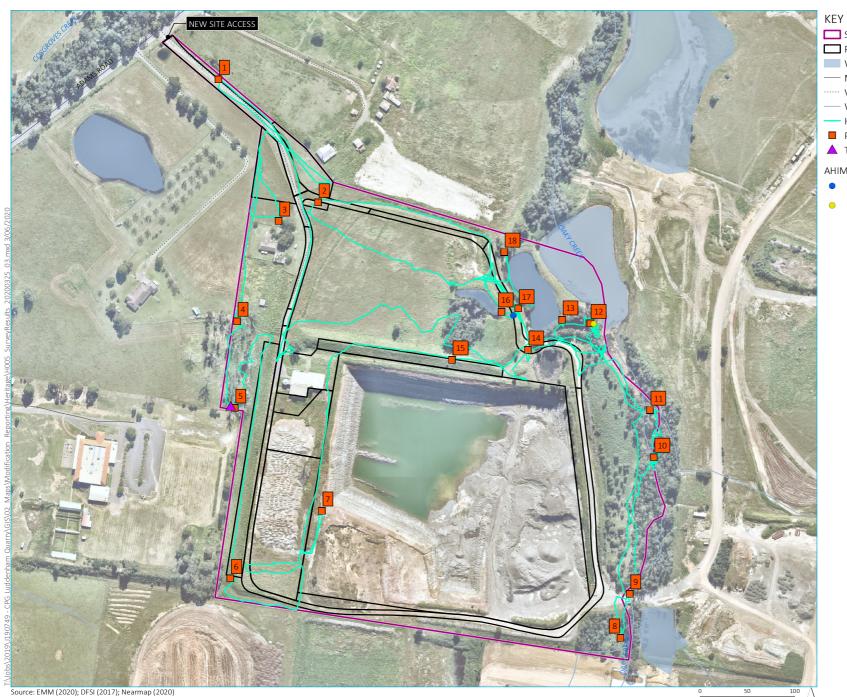
The only area of moderate archaeological potential includes a corridor, approximately 50 m wide along the section of Oaky Creek to the south of the dams. Oaky Creek runs south to north along the eastern boundary of the study area but is outside the proposed disturbance footprint of the project (Figure 1.2).

An overview of the site assessment is shown in Figure 4.1. Photographs corresponding to points on the figure are included in Appendix B.
